Theoretical and Experimental Considerations Regarding the Evaluation of the Mechanical Characteristics of Polyethylene Pipes Under Multiple Loading Conditions

Abstract

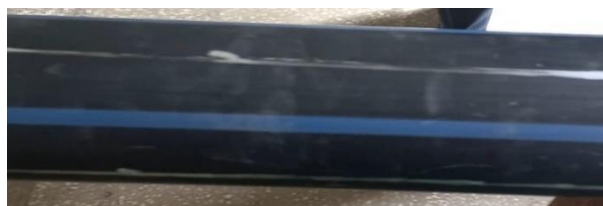
Figure 3. The PE100 polyethylene pipe used for the multiple stress test

The PE100 polyethylene pipe used for the multiple stress test (Figure 3) had the following dimensional and material characteristics: pipe outer diameter, $D_e = 90$ [mm]; wall thickness, $s = 5.4$ [mm], pipe length, $L_{pipe} = 4000$ [mm]; pipe material density, $\rho_{PE100} = 960$ [kg/m³].

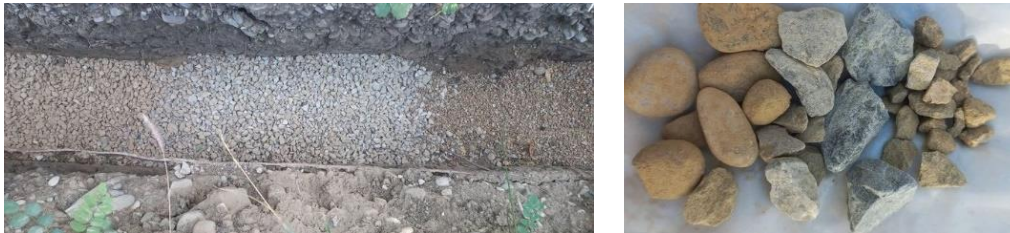
a) b)
Figure 4. Aspects of laying a PE100 polyethylene pipe in a trench:
a) pipe bedding; b) backfill material

The pipe was laid in an irregular trench, without supervision, with soil with stones or rocks for which n_2 - coefficient that takes into account the type of terrain is $n_2 = 6$, being unsettled terrain. The pipe bedding, made of the filling material, is shown in Figure 4a. The backfill material used in the experiment is shown in Figure 4b.

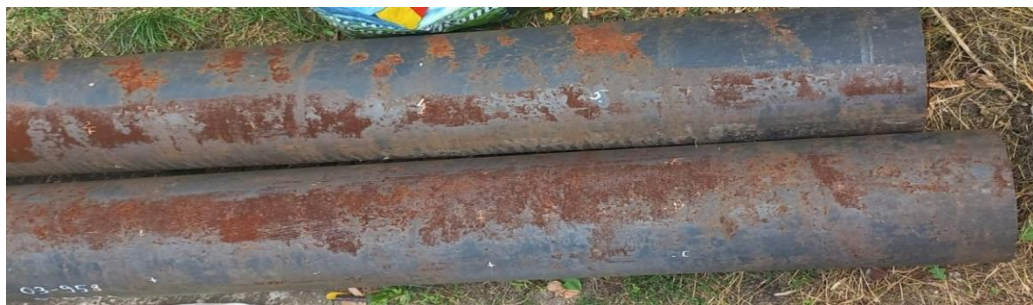
Figure 5. Metal tubes used to simulate the load due to street traffic

The metal tubes, two in number, were used to simulate the load due to street traffic, P_t . Thus, the experiment used the additional load produced by the weight of the two metal tubes, shown in Figure 5, having: tube outer diameter, $D_{tube} = 250$ mm, tube wall thickness, $s_{tube} = 11.3$ mm, tube length, $L_{tube} = 1840$ mm, and tube material density, $\rho_{steel} = 7.85 \cdot 10^3$ [kg/m³].

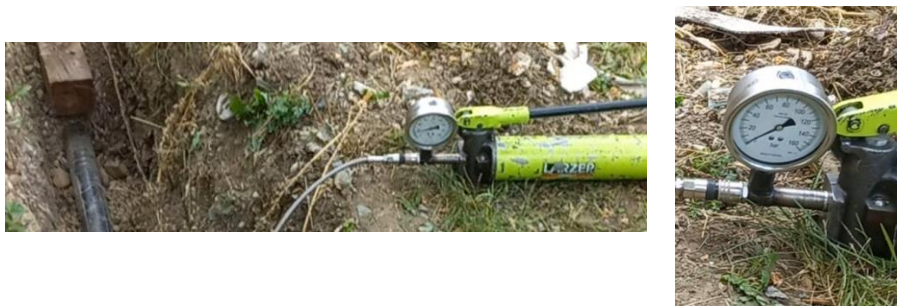
a) b)
Figure 6. The Rems Push manual pressure test pump: a) general view; b) detail

In the multiple stress test of the buried PE100 polyethylene pipe, the Rems Push manual pressure test pump (Figure 6a), with a maximum pressure of 160 bar (Figure 6b), the Shangli CPCD30 diesel forklift (Figure 7) and the experimental facility used for testing of polyethylene pipes were used.

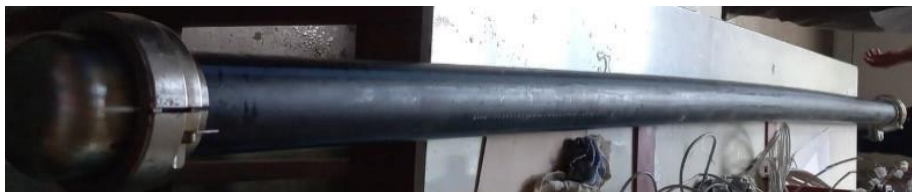
Figure 8. Pipe with type A caps mounted at its ends

The PE100 polyethylene pipe used in the experimental test had caps applied to ensure sealing of the ends (Figure 8). Type A steel caps were installed with threaded connections, shown in figure 9, according to ISO 1167-1.

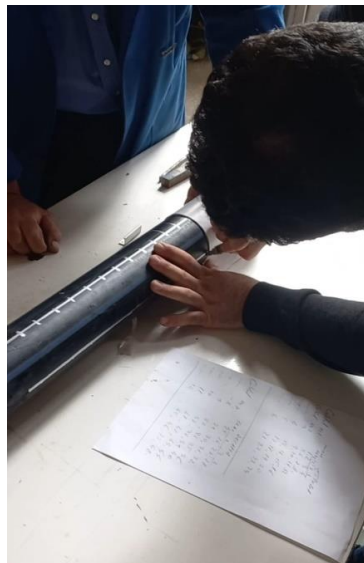
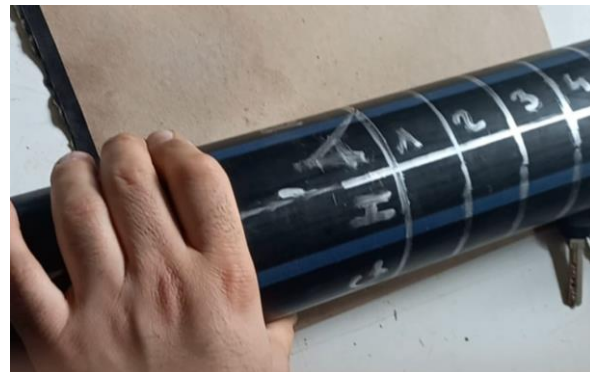
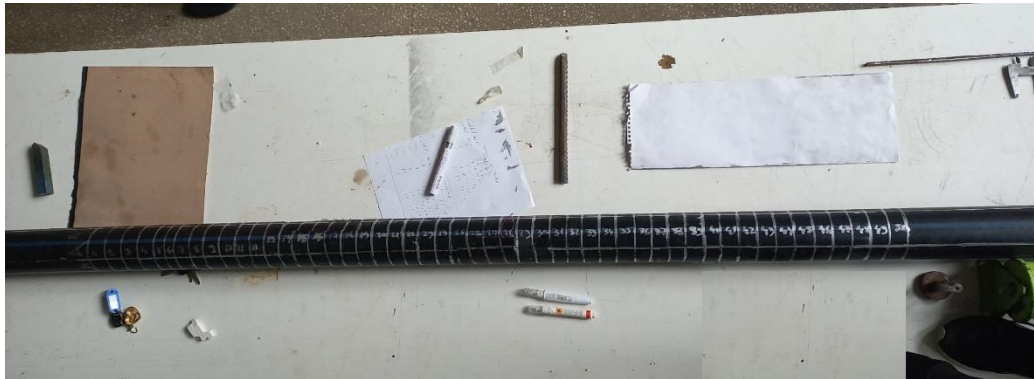
Figure 10. Creating a graphic representation of the marks on the surface of the PE100 pipe: a) drawing the circumferential marks; b) drawing the horizontal marks; c) the final appearance of the graphic representation of the marks drawn on the outer surface of the PE100 pipe

The distance between two consecutive circumferential marks - along the length of the pipe - was 30 mm (Figure 10a), and the distance between two consecutive horizontal marks - along the circumference of the pipe - was 40 mm (Figure 10b). Circumferential markers from 1 to 50 and horizontal markers from A to H were drawn (Figure 10c).

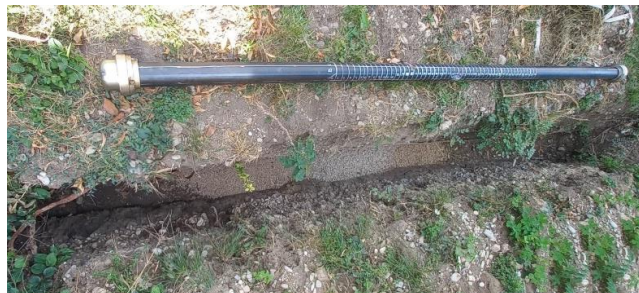
Figure 11. Pipe in the preliminary stage of installation in the trench

Pipe is shown in the preliminary stage of installation in the trench in the figure 11.

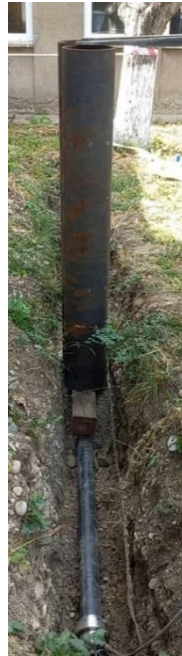
Figure 12. Applying an external load (122.3963 kg) to the defect area to simulate localized traffic overload

Figure 12 shows the overlapping of metal tubes over PE100 polyethylene pipe for the purpose of simulating traffic overload.

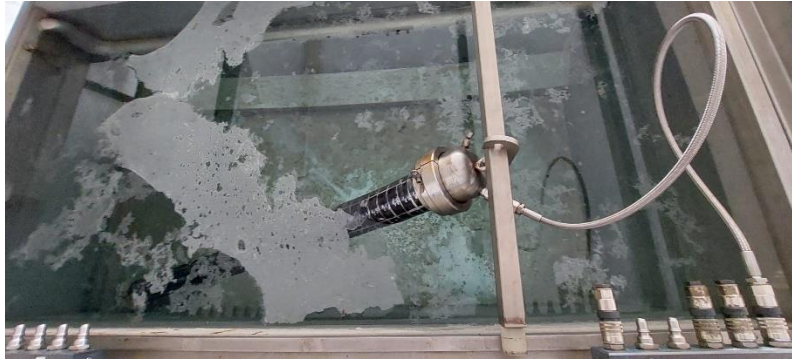
Figure 14. Internal pressure testing of the pipe

After internal pressure testing of the pipe (figure 14), it was found that the defect identified in the form of a scratch, shown in figure 13c, was the defect that caused the pipe to burst.

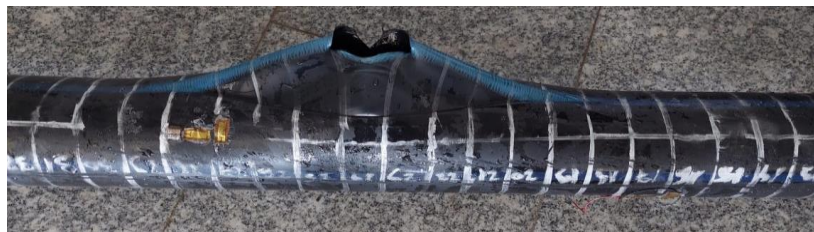
Figure 18. PE100 polyethylene pipe failure evaluated under multiple stress conditions

The polyethylene pipe bursting occurred through local swelling around the defect identified as being located in the GH 23-26 space, concomitant with wall thinning until failure (Figure 18). The length of the portion of the pipe affected by the rupture was 35 mm.

The pipe failure was ductile, also known as “parrot beak” (figure 18).

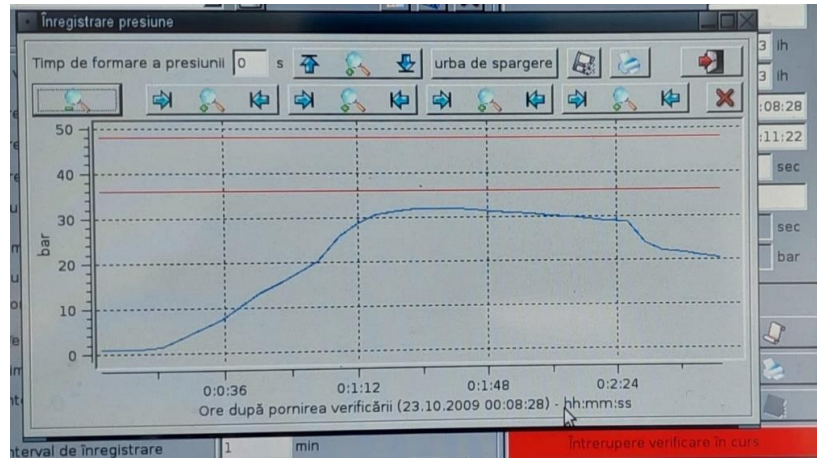
Figure 19. Pressure-time diagram (bar – s) for PE100 polyethylene pipe evaluated under internal pressure test stage

The burst pressure values and burst time values recorded for the PE100 polyethylene pipe evaluated under multiple stress conditions are presented under the pressure-time (bar-s) diagram, shown in Figure 19 and Table 3.

The maximum value of the internal pressure recorded during the internal pressure stress of the PE100 pipe was $P_{i,max} = 33 \text{ bar}$. This was the value at which the pipe depressurization began – corresponding to the bursting time of 149 s – test fluid leaks occurred or the process of water leakage from inside the pipe was initiated.

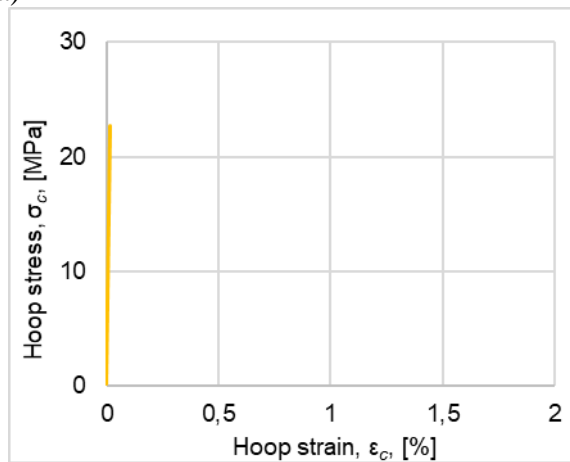
Figure 20. Diagrams for PE100 polyethylene pipe evaluated under internal pressure test stage: a) $P_i - t$; b) $\sigma_c - P_i$; c) $\sigma_c - \epsilon_c$; d) $\sigma_l - P_i$

To study the behavior of the PE100 polyethylene pipe evaluated under multiple stress conditions, the following diagrams were drawn: internal pressure - time, hoop stress - internal pressure, hoop stress - hoop deformation and axial stress - internal pressure (Figure 20).
